Juneau Airport Wind System (JAWS) Wind Sensor Severe Weather Performance Test Report

August 2002

DOT/FAA/CT-TN02/18

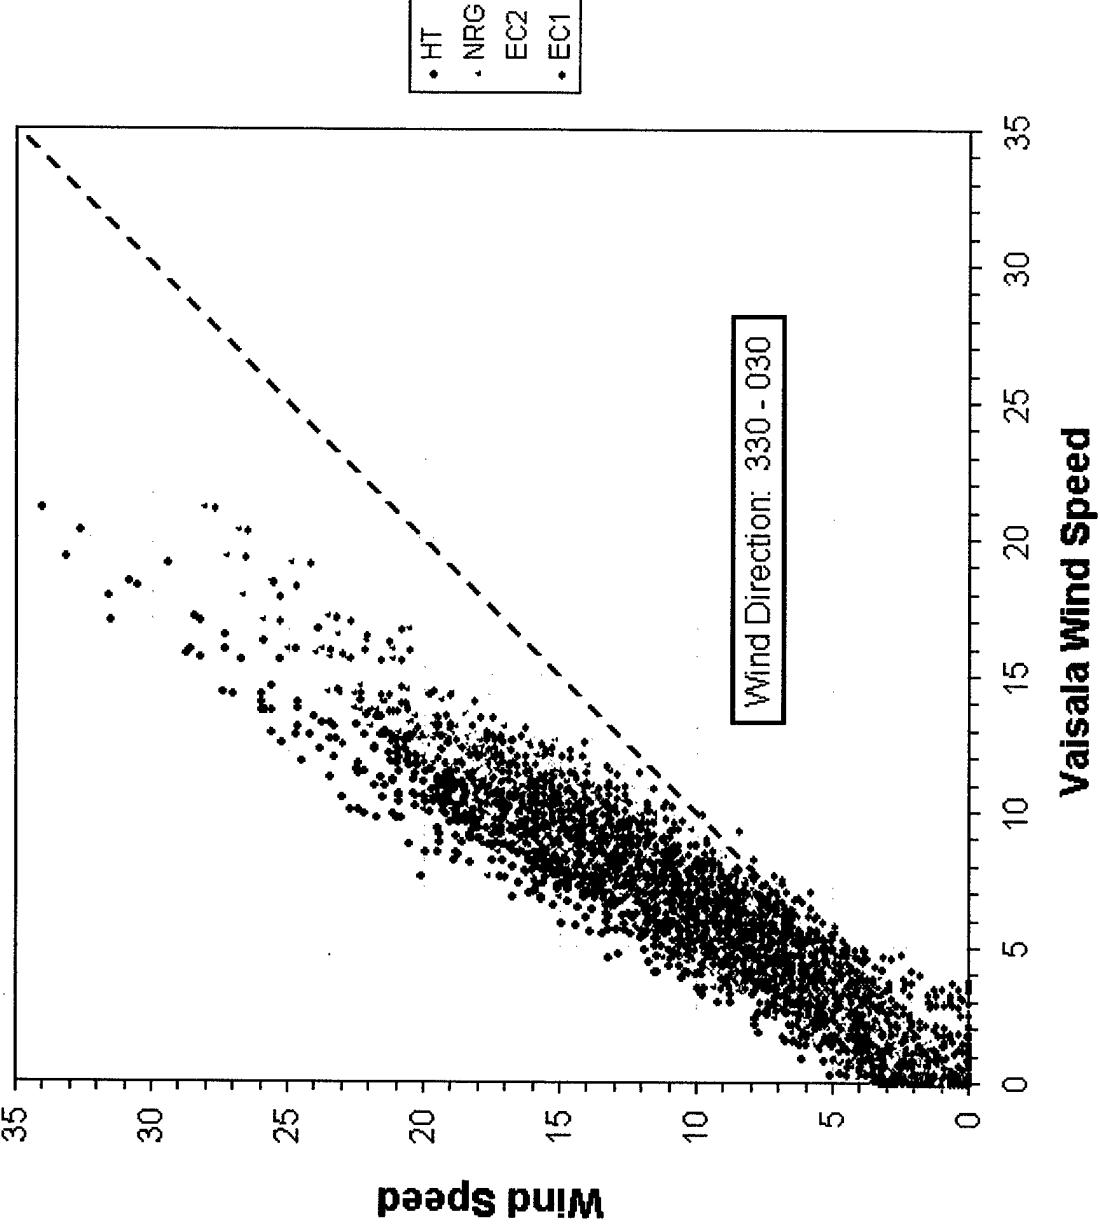
Performance of the sensor was found to be consistent with data from the wind tunnel tests and results from the MWO study. Typical cases showing a comparison of wind speed against the Vaisala anemometer is provided in figures 57 through 60. Due to the inertia of the ruggedized sensor, the observed overspeeding and a low starting threshold was expected. The overspeeding indicated in the figure is particularly pronounced for northerly winds and is possibly exacerbated by the upslope winds at Eagle Crest in this direction. The off-axis overspeed response inherent to the sensor was also noted in the wind tunnel tests.

FIGURE 59. WIND SPEED DISTRIBUTION FOR NORTH WIND

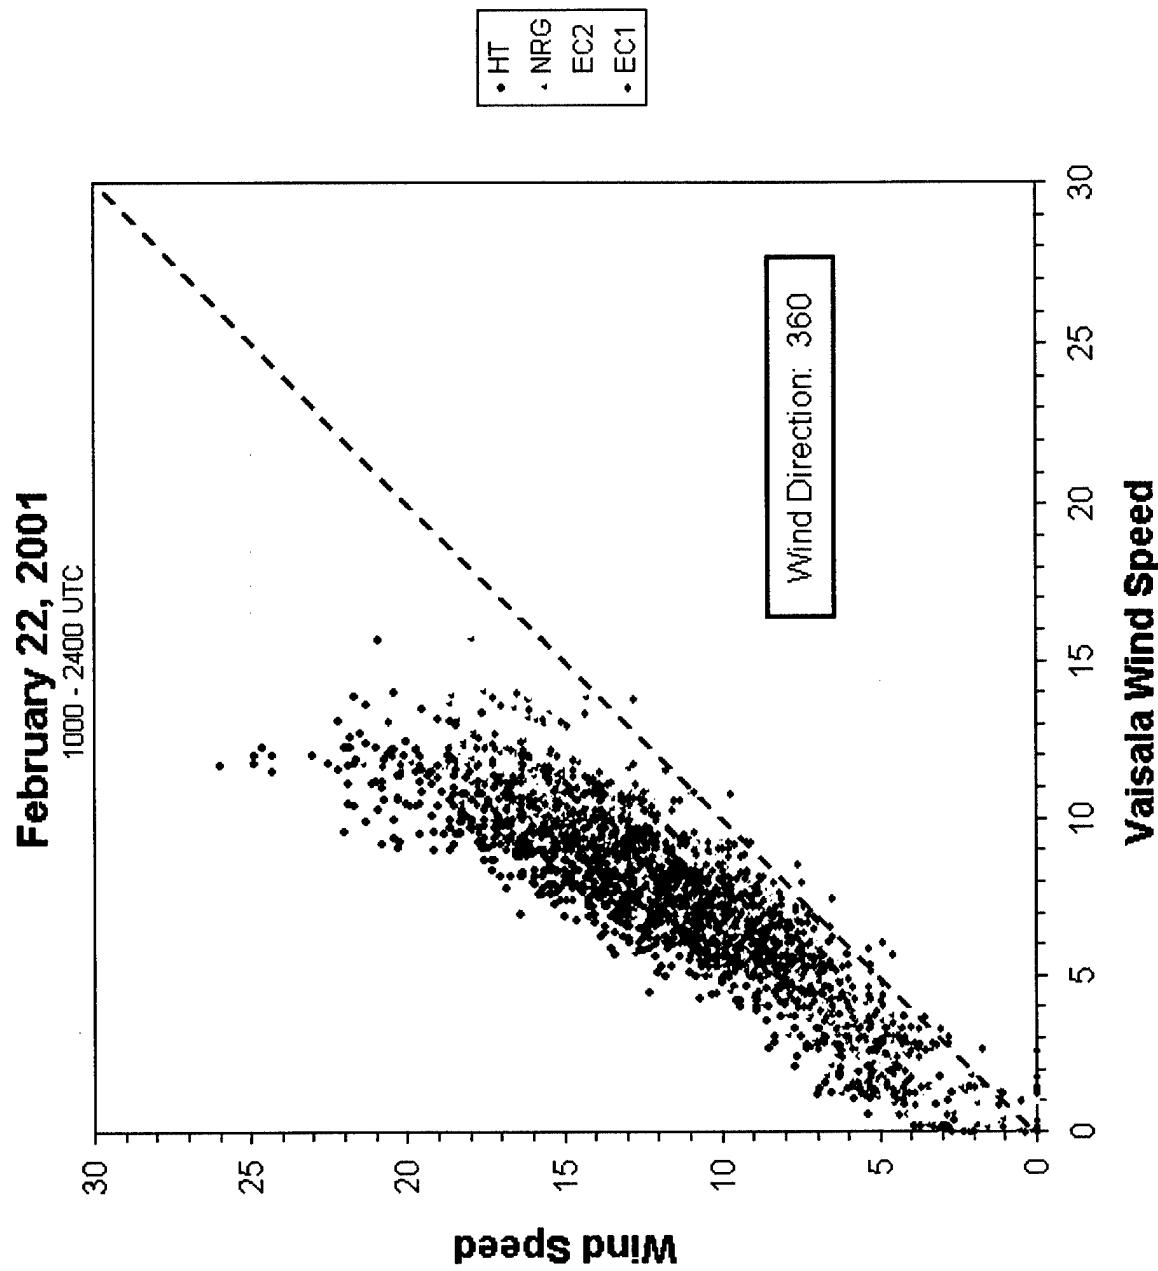
FIGURE 60. WIND SPEED DISTRIBUTION FOR NORTH WIND

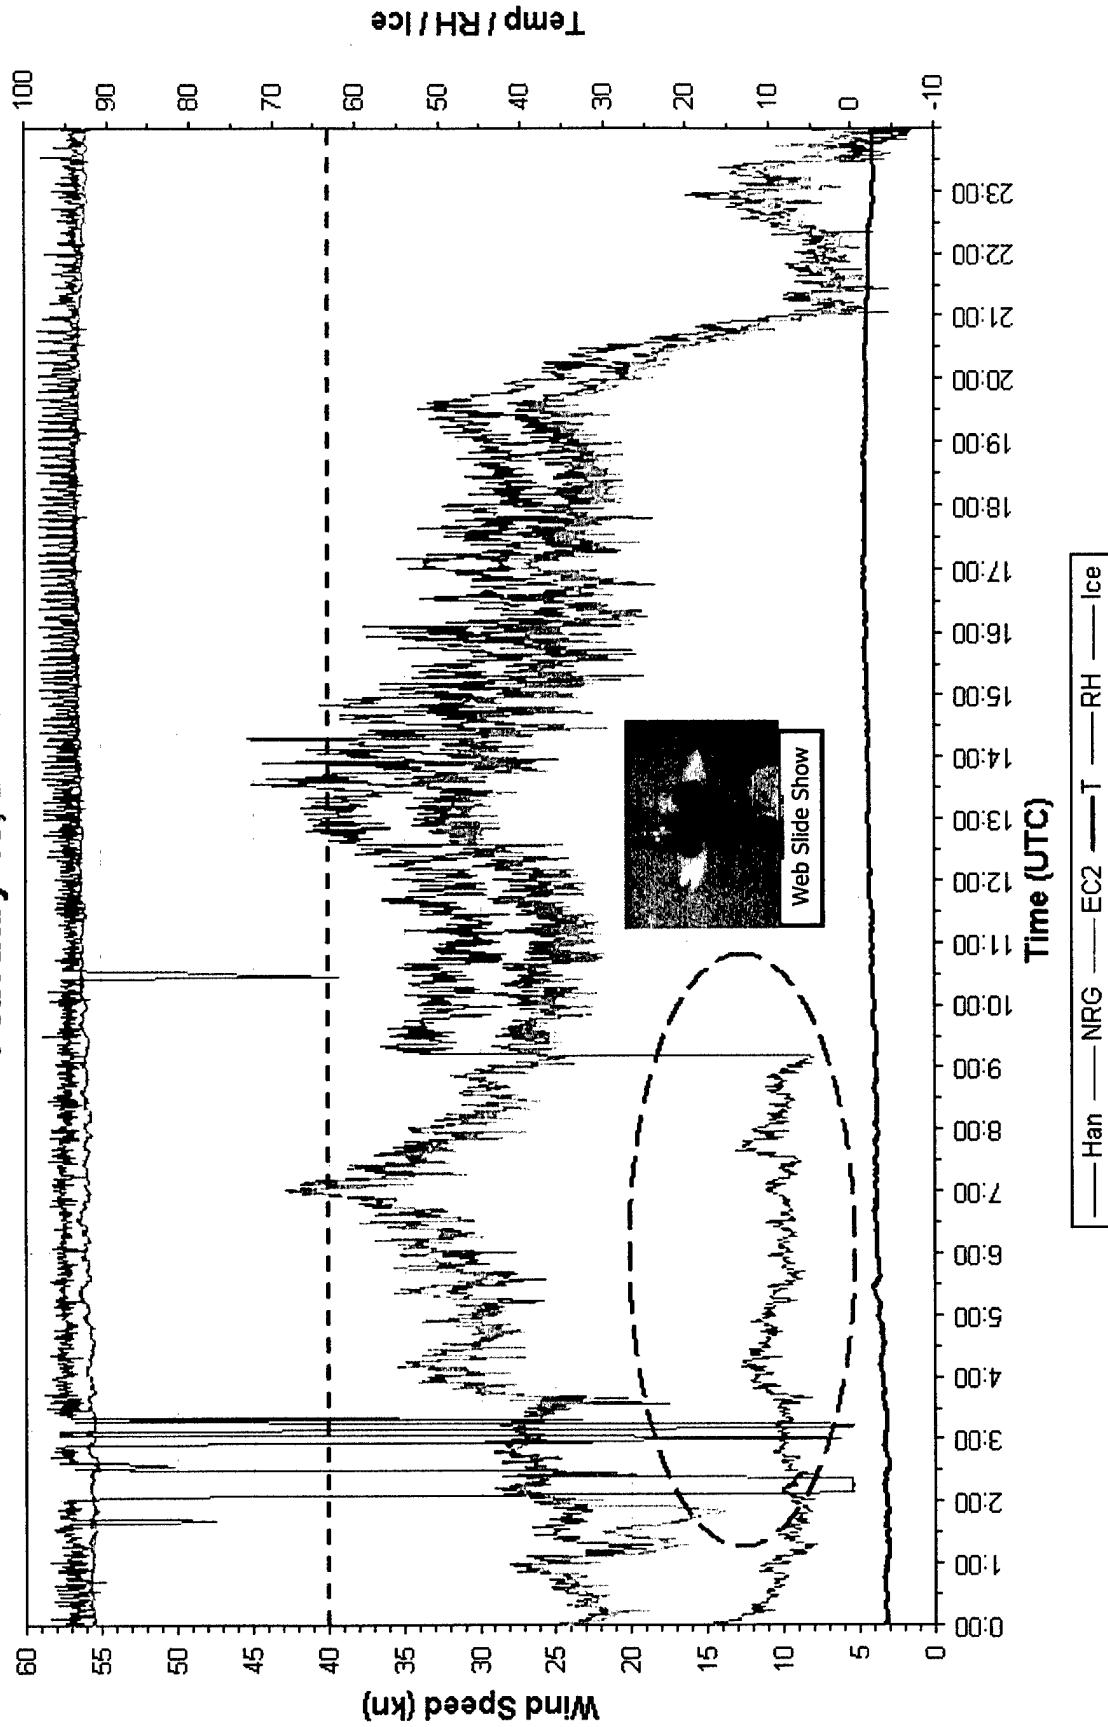
February 13, 2001

FIGURE 61. NRG ROTOR FAILURE DURING AN ICING EVENT

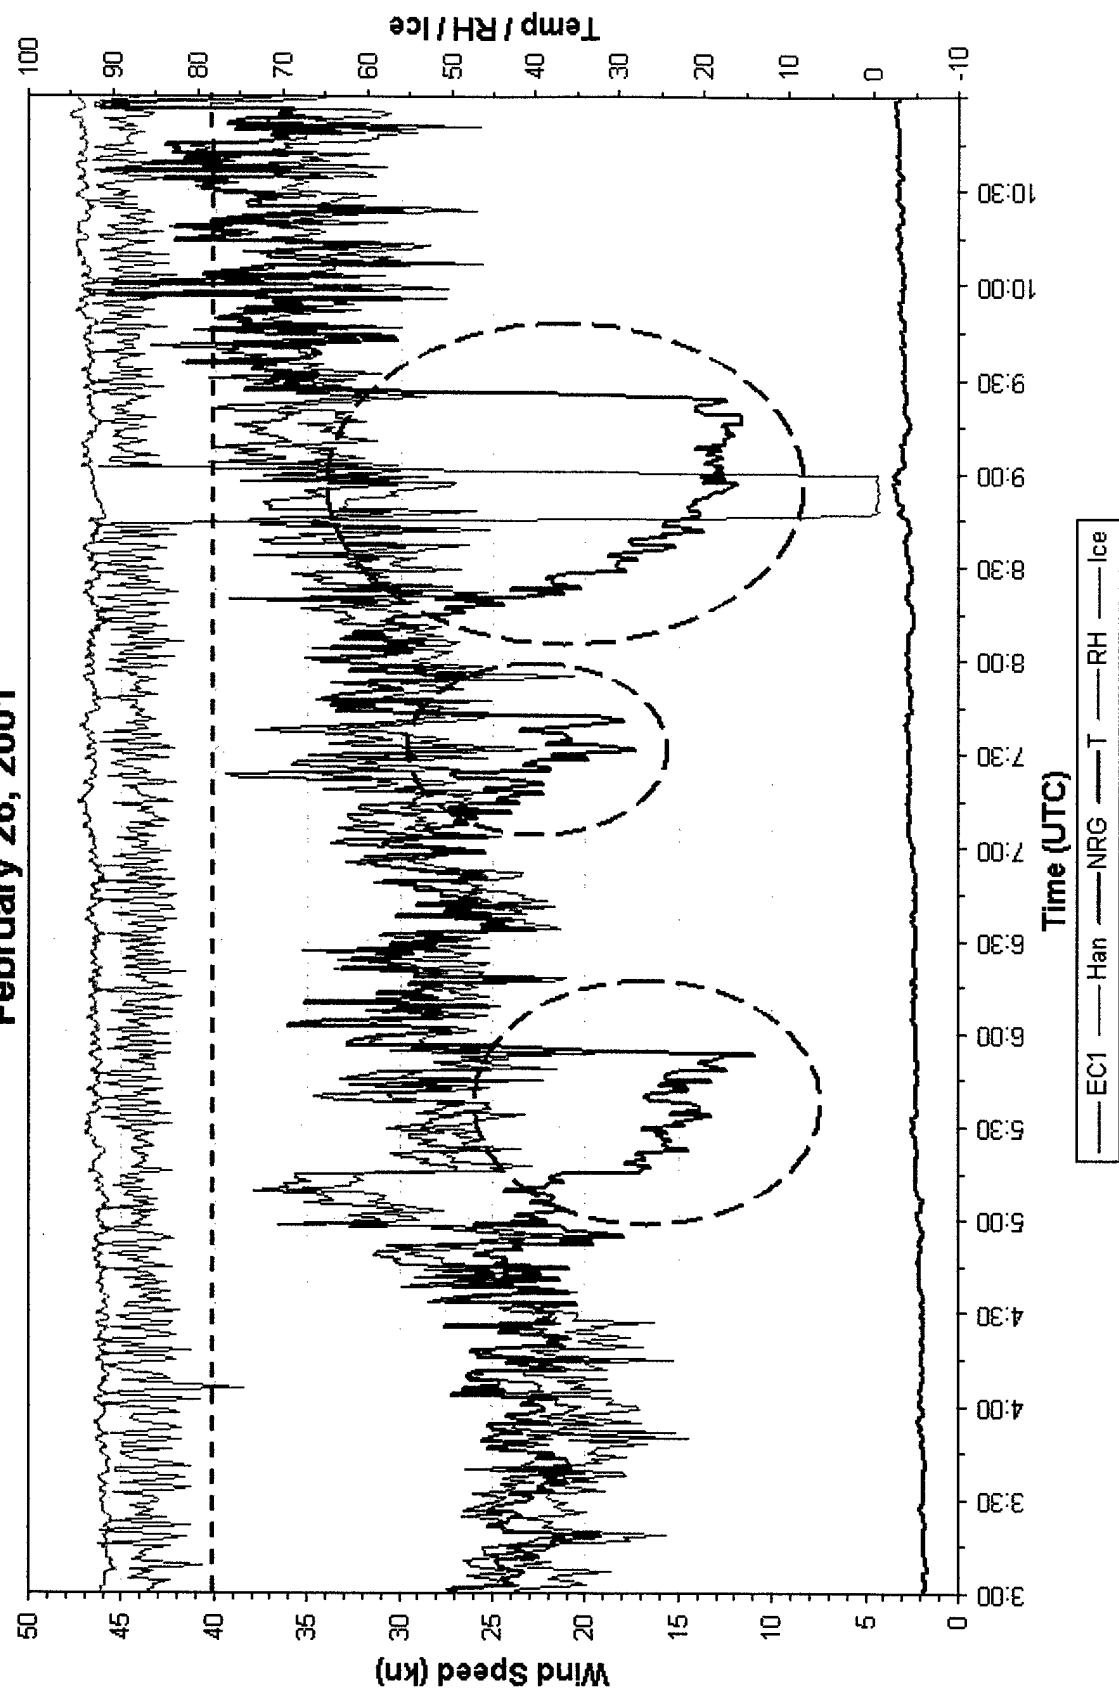
February 26, 2001

FIGURE 62. NRG ROTOR FAILURES DURING AN ICING EVENT

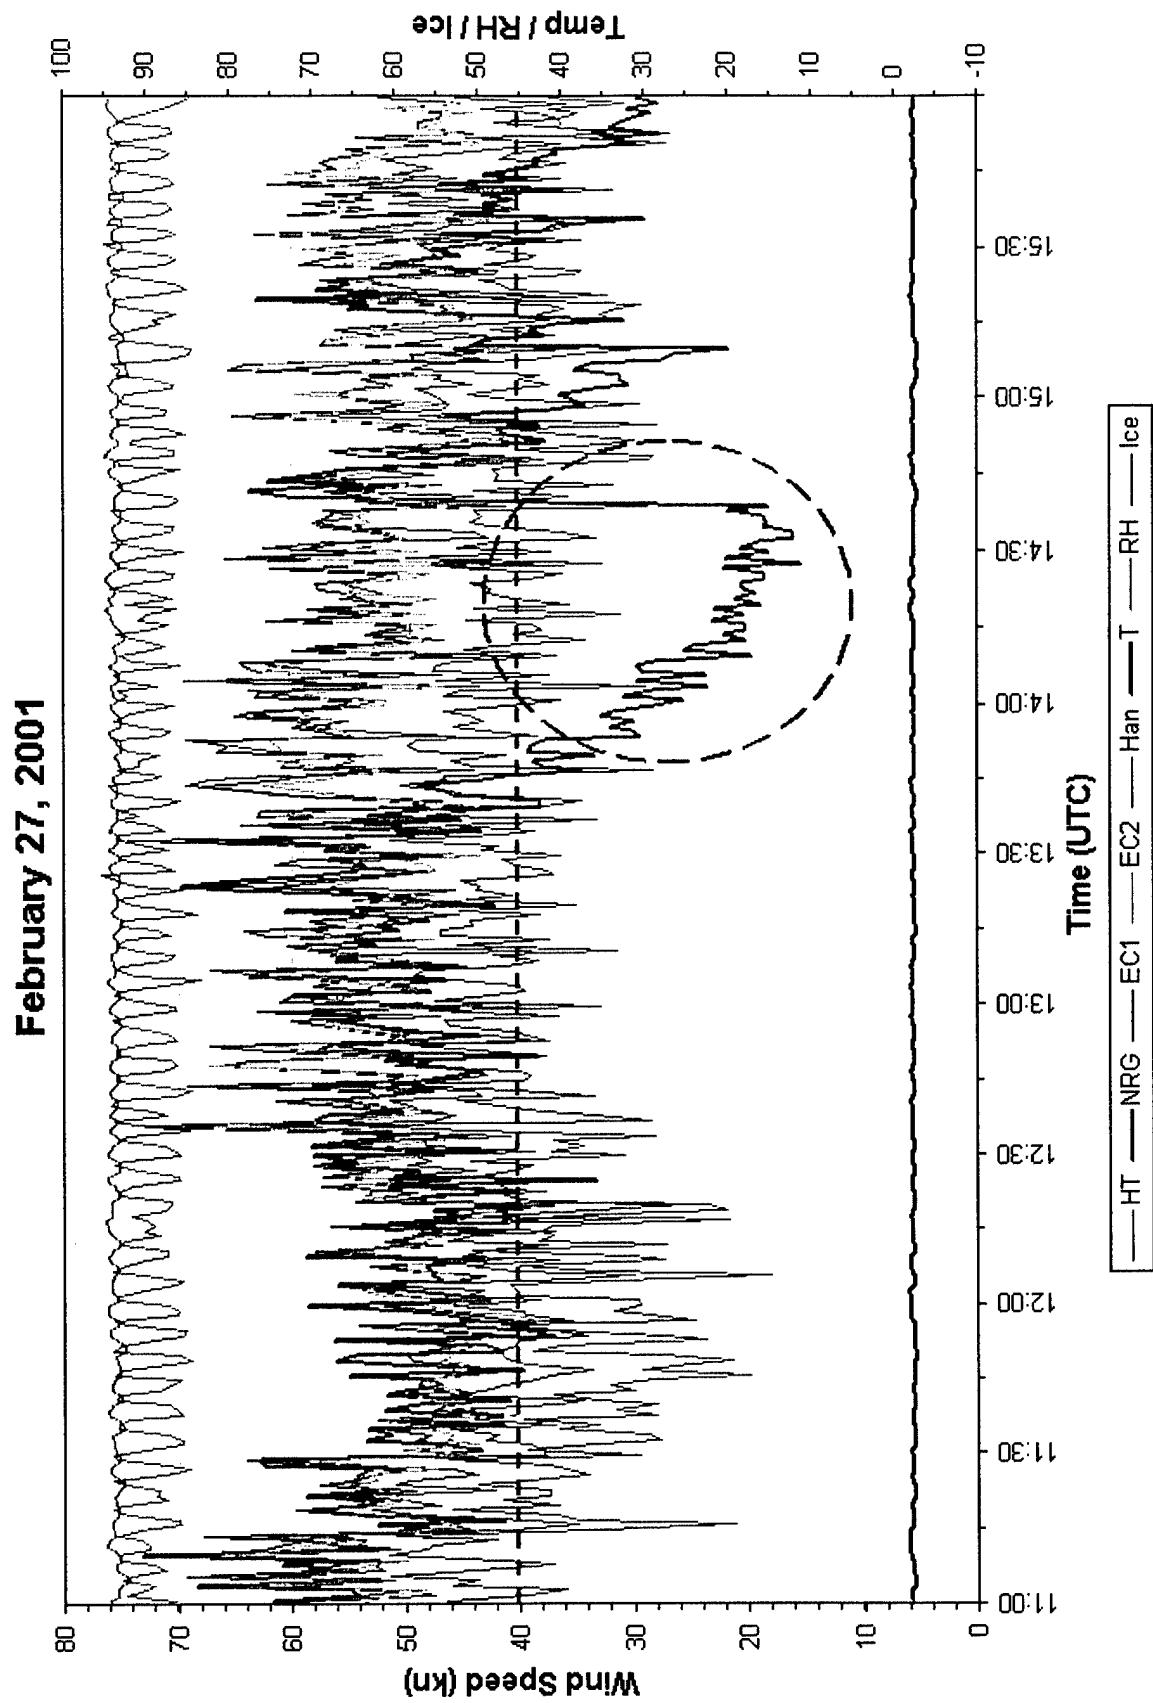
FIGURE 63. NRG ROTOR FAILURE DURING AN ICING EVENT

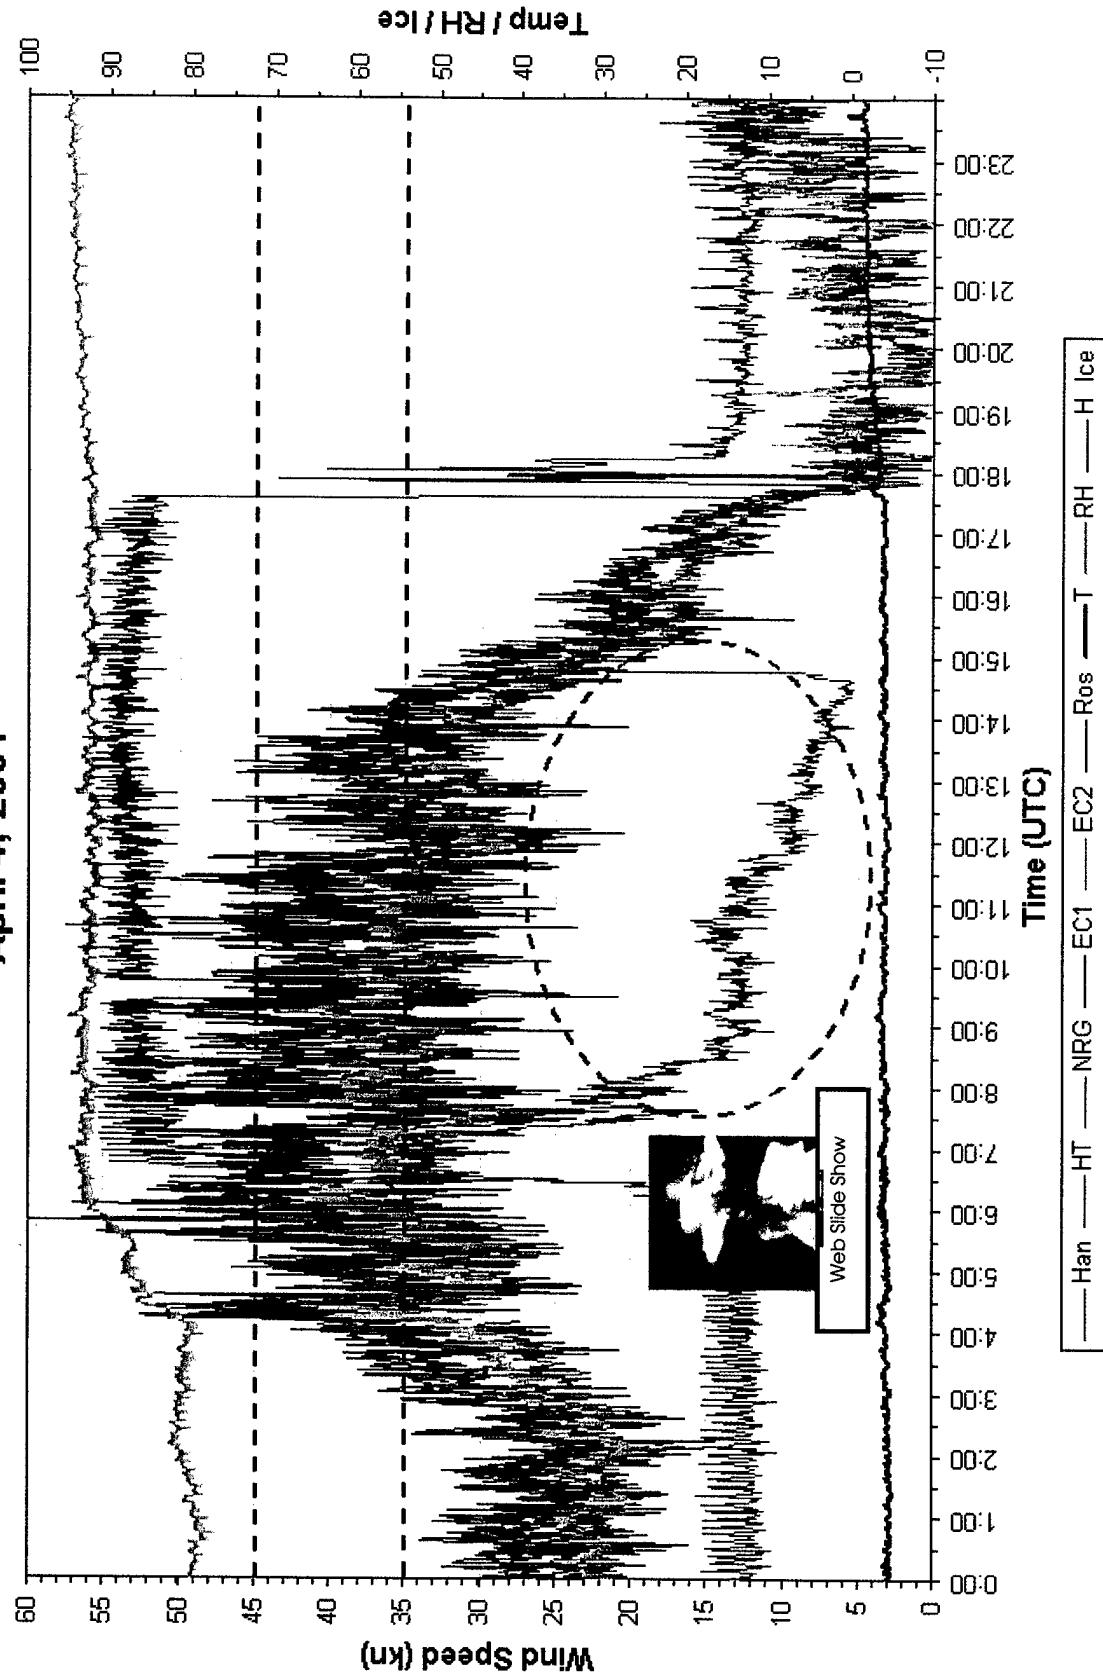
April 4, 2001

FIGURE 64. NRG ROTOR FAILURE DURING AN ICING EVENT

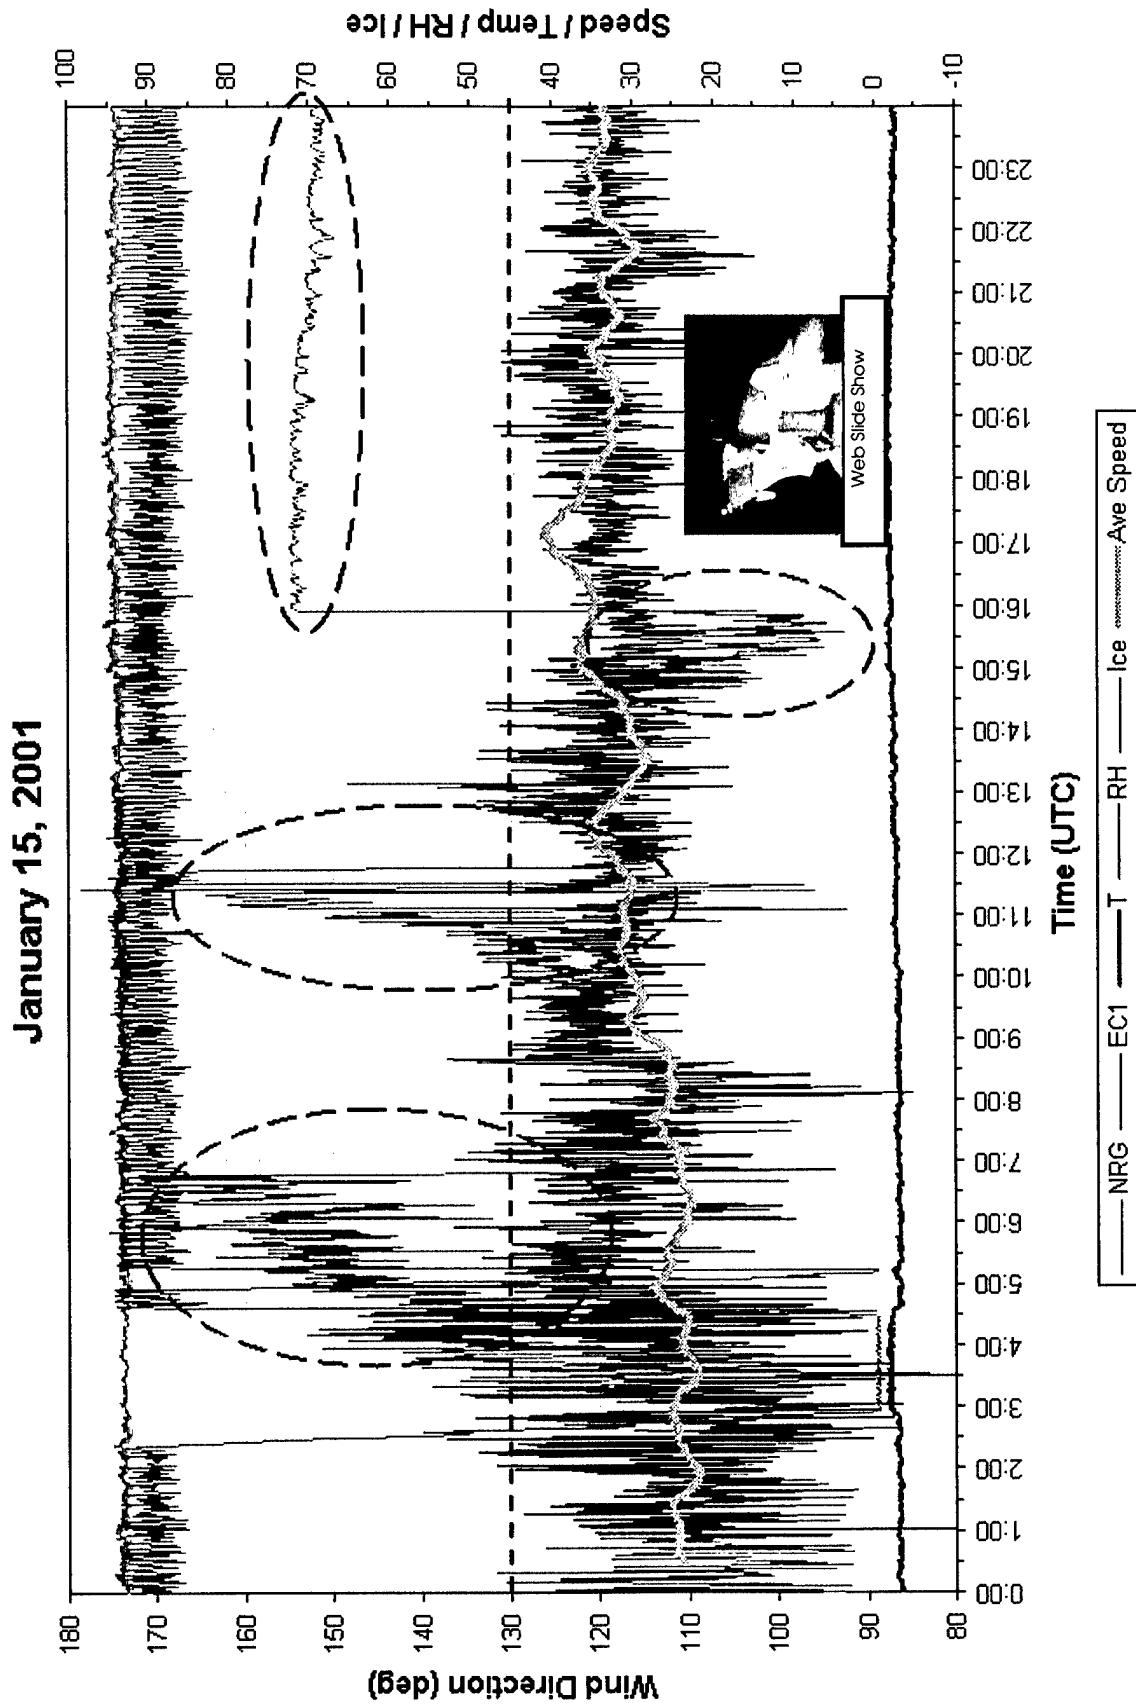
FIGURE 65. NRG DIRECTION VANE FAILURE DURING AN ICING EVENT

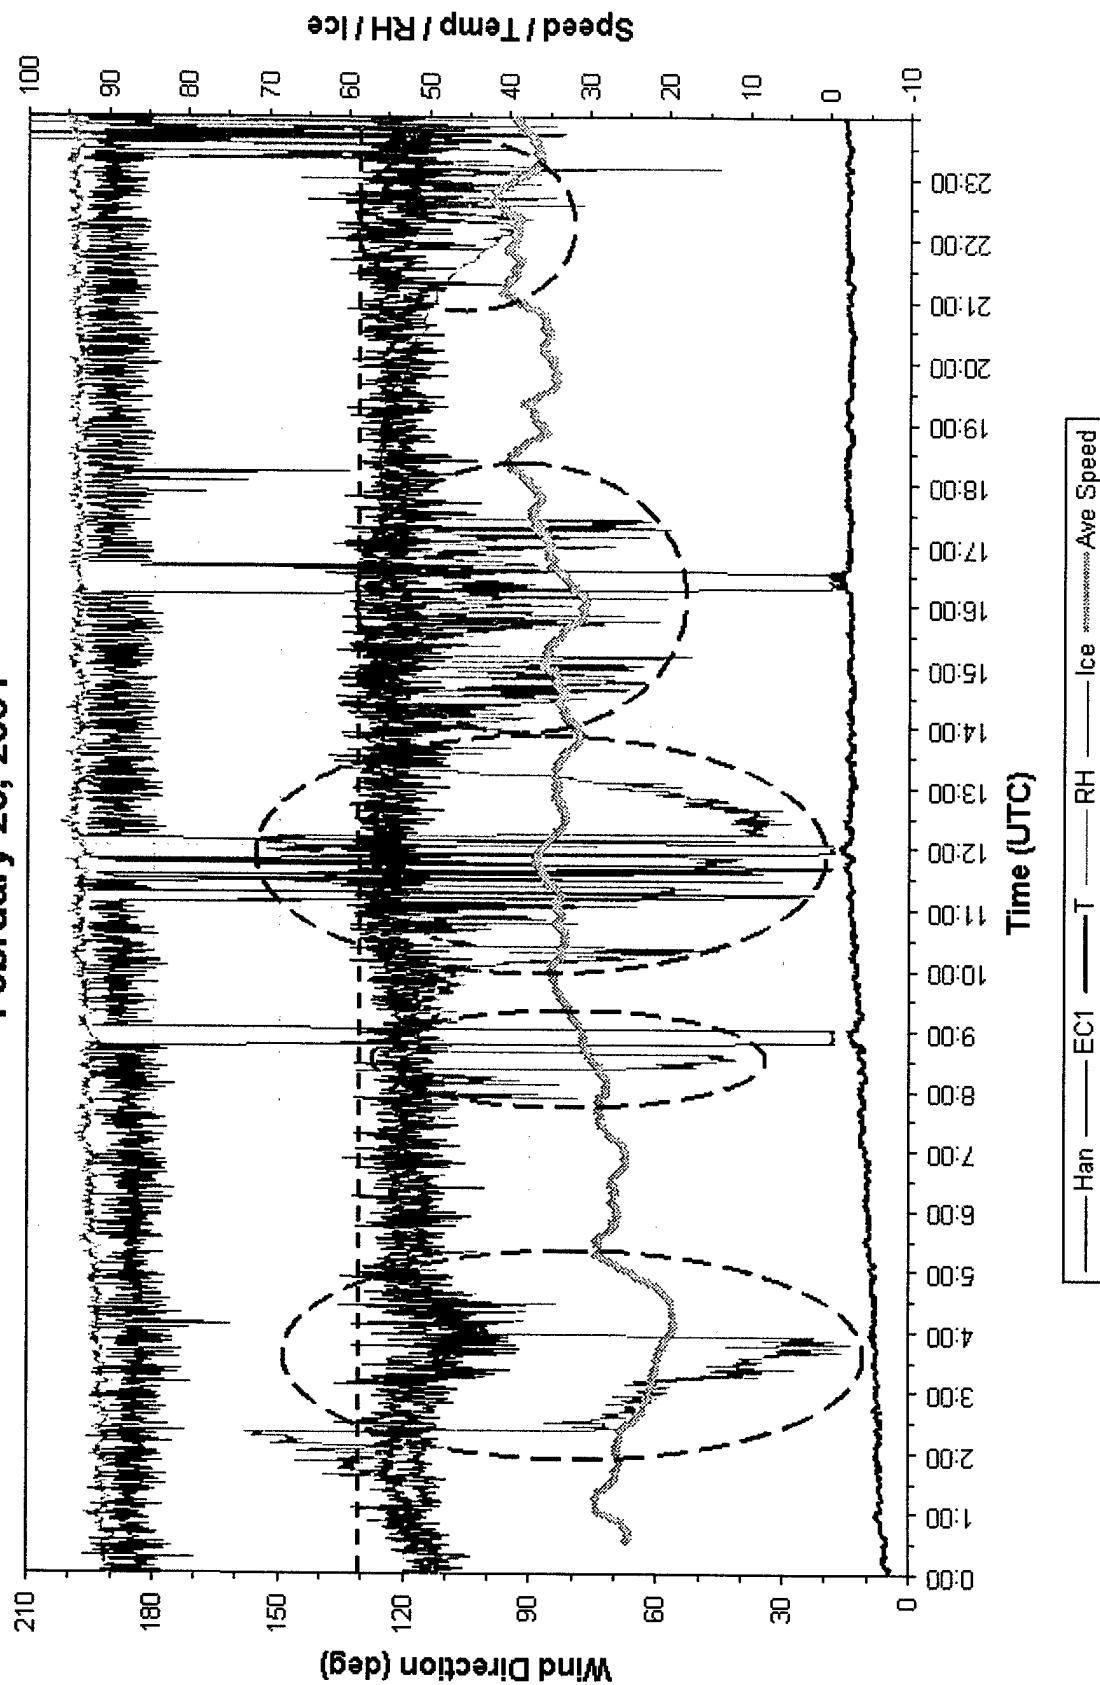
February 26, 2001

FIGURE 66. NRG DIRECTION VANE FAILURES DURING AN ICING EVENT

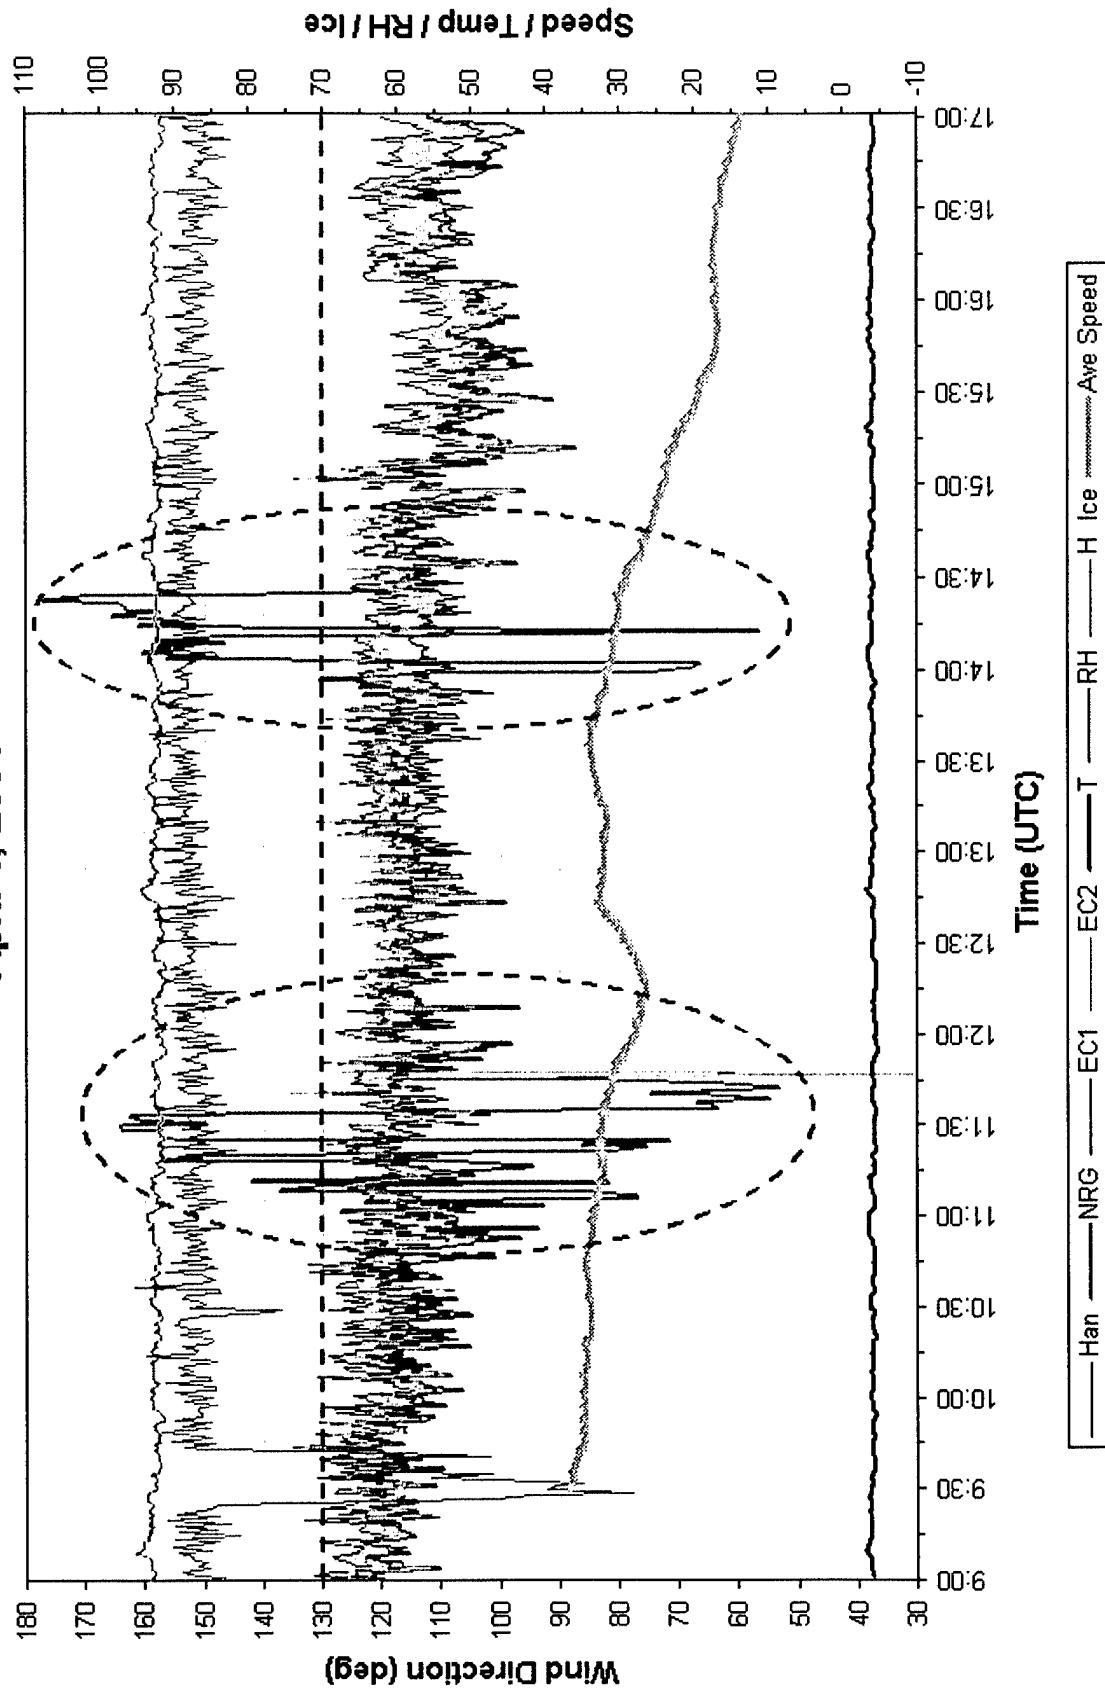
April 4, 2001

FIGURE 67. NRG DIRECTION VANE FAILURES DURING AN ICING EVENT

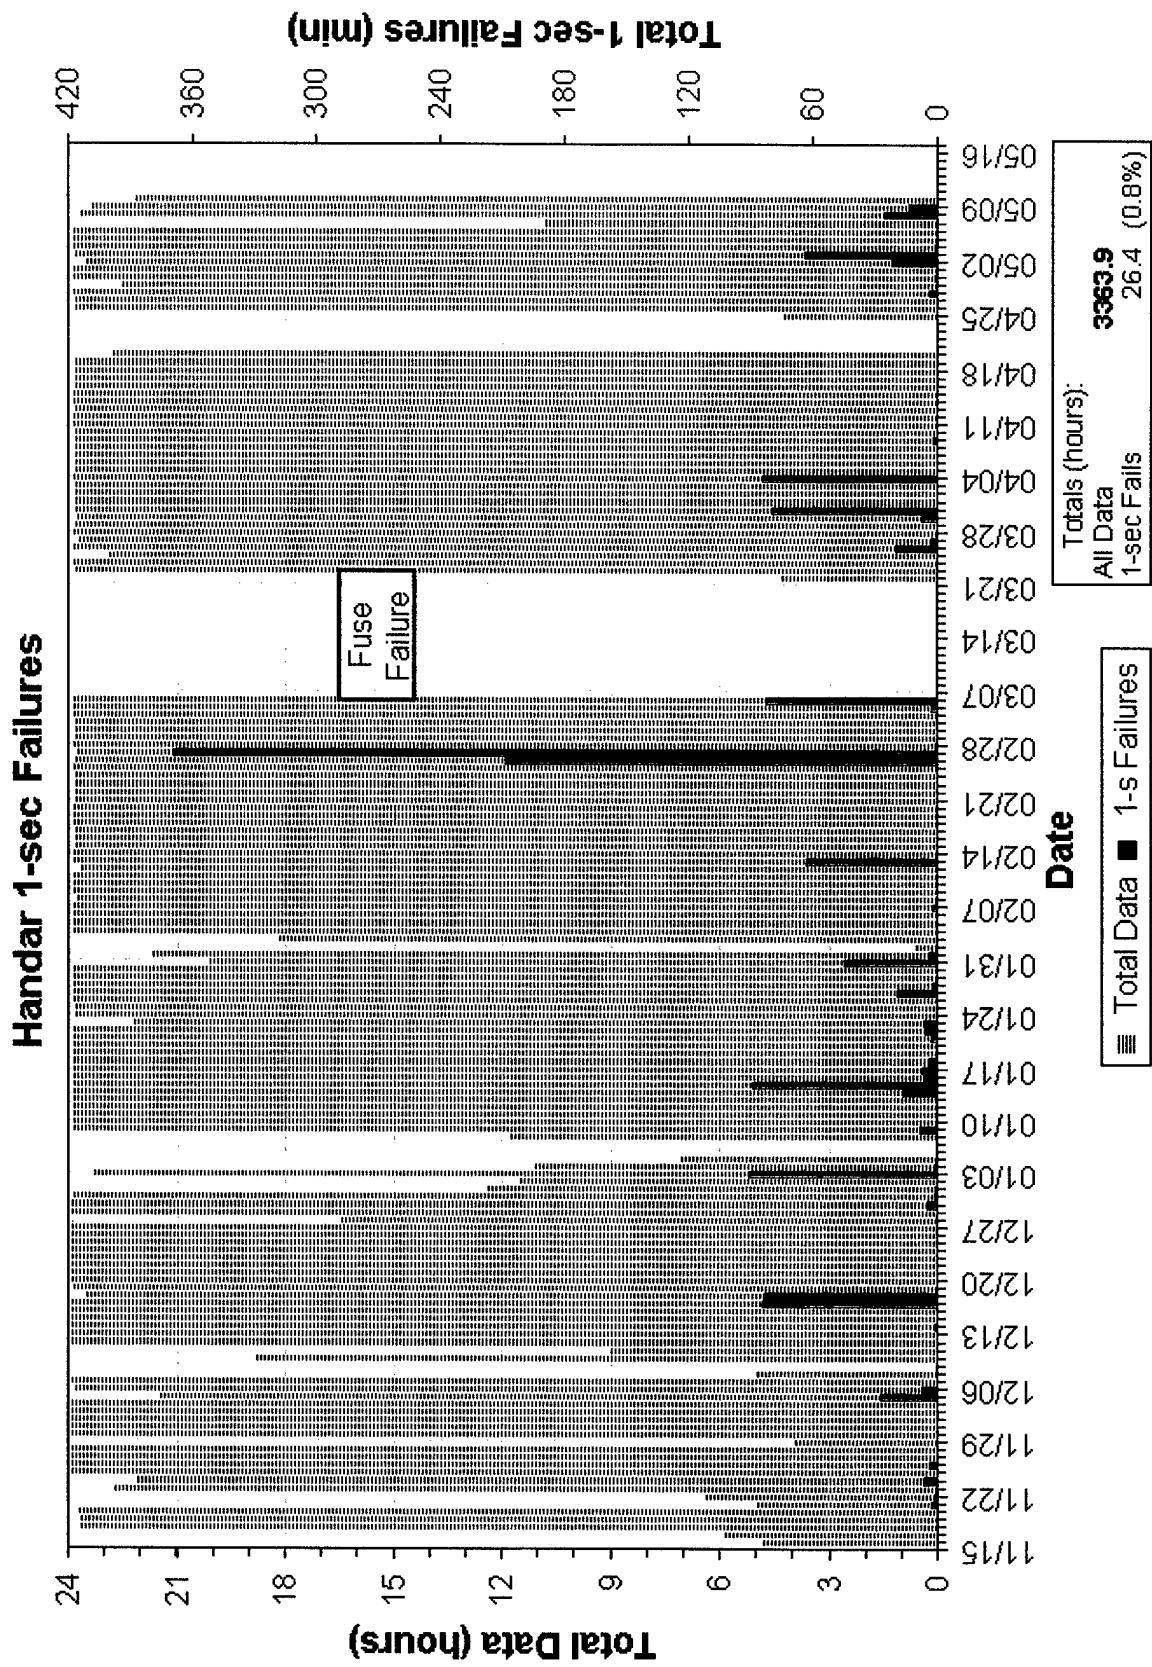
A total of 3364 hours (~140 days) of sonic anemometer data were recorded and collected. The distribution of failures based on the 1-second raw sensor data is shown in figure 68. The sensor was determined through its internal status, as well as video data, to be degraded by icing 26.4 hours (or 0.8%) of the 6-month period. A failure qualifies as a bad data flag received from the sensor because of unreliable readings. Review of the camera data indicates that the failures appear highly correlated to snow and icing conditions. However, unlike the MWO study where there were instances where the sensor was in complete failure-mode over periods ranging from 2 to 3 continuous hours, the events of sensor failures at JNU were generally intermittent in nature, with frequencies of occurrence proportional to the severity of the weather conditions.

FIGURE 68. DISTRIBUTION OF VAISSALA 1-SECOND SENSOR FAILURES

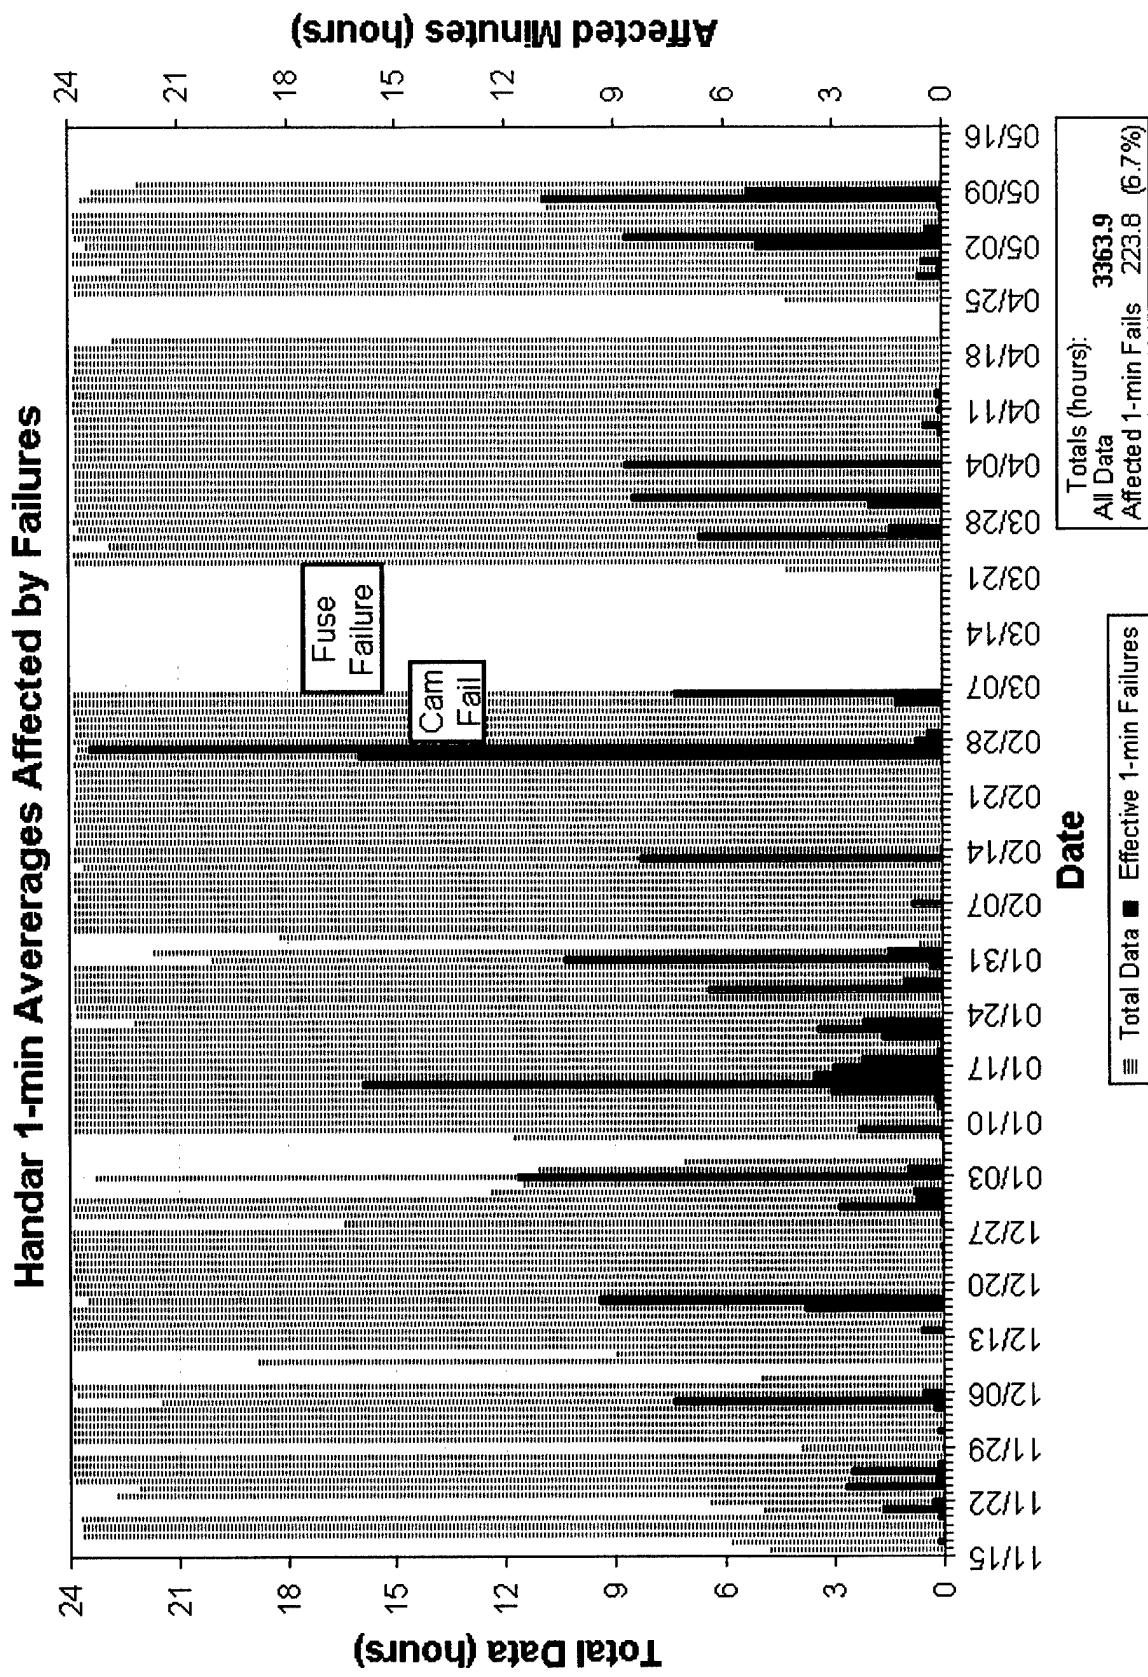
Further analysis of the periods of degraded performance, with respect to the JAWS 1-minute wind reporting requirement, was next performed. The affected 1-minute averages are shown in figure 69. An affected 1-minute average is a 1-minute mean wind value where at least 1 of the 60 constituent 1-second samples is flagged as bad. The composition of the affected 1-minute averages is reflected in the frequency histograms in figure 70. The analysis revealed that in 84% of affected cases, there were at least 75% raw data samples available to derive a valid wind report. During the entire field experiment, only 81 sporadic 1-minute wind reports were derived from 25% or less raw 1-second samples.

FIGURE 69. DISTRIBUTION OF VAISSALA 1-MINUTE AVERAGES AFFECTED BY SENSOR FAILURES

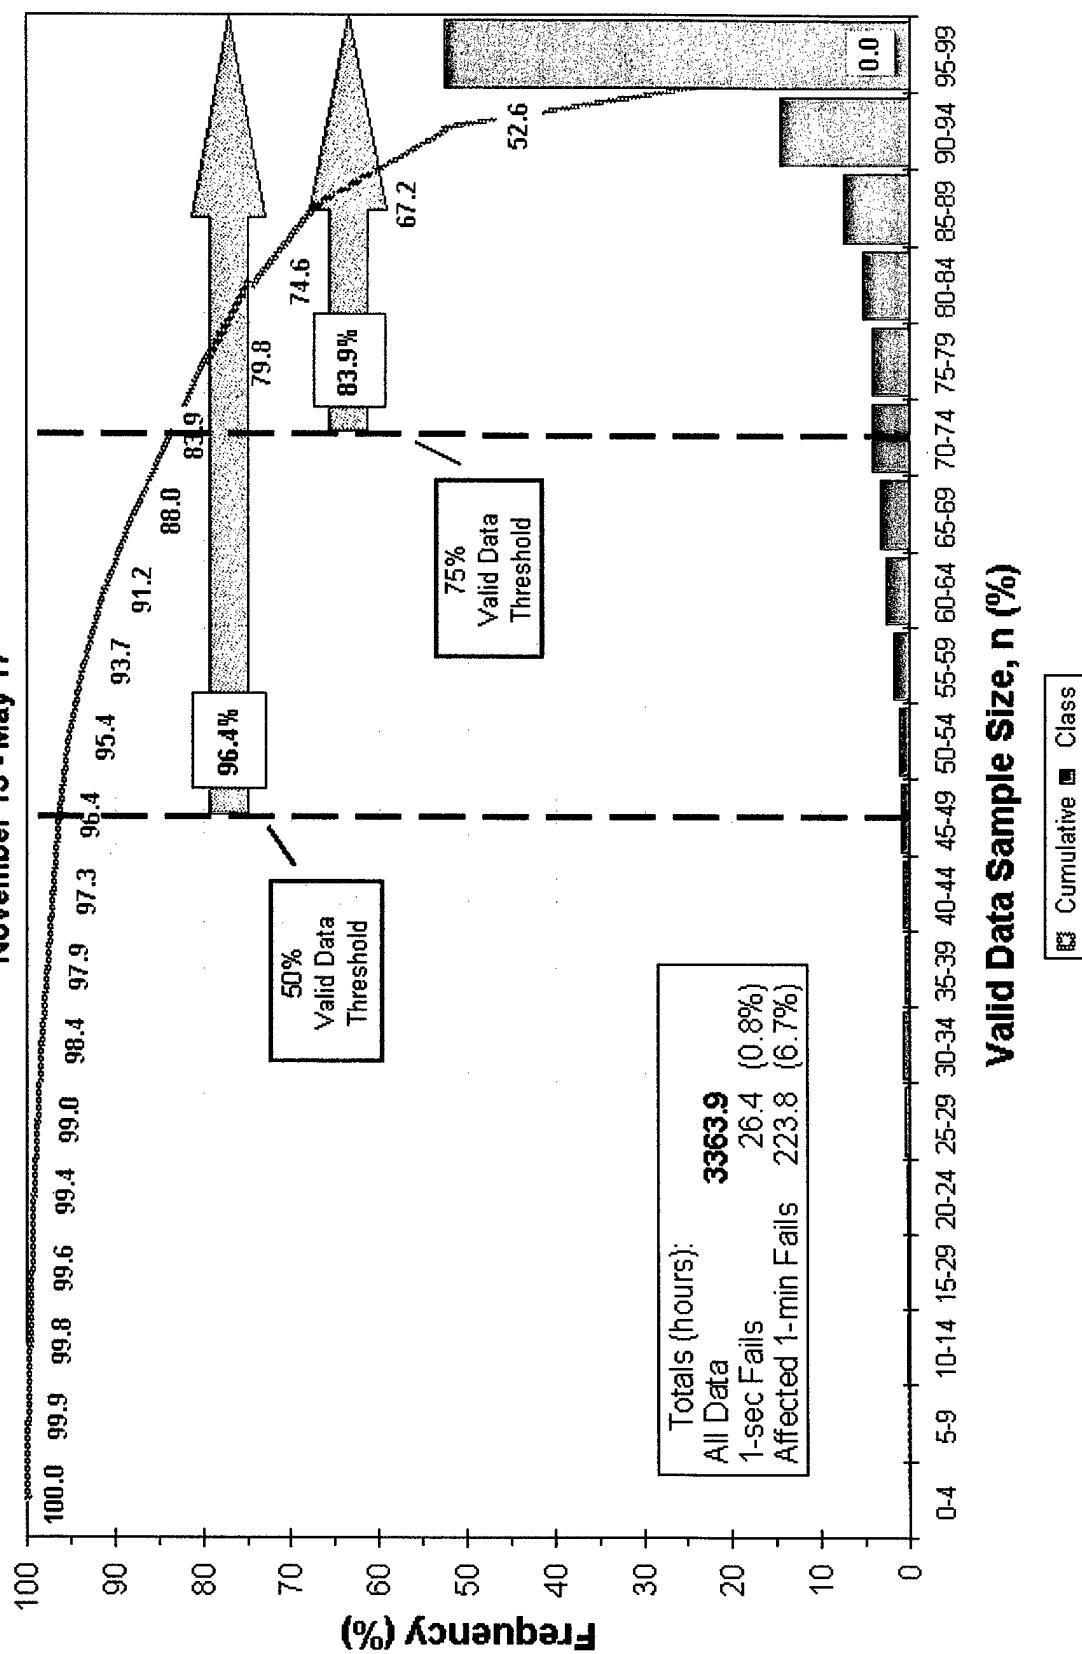
FIGURE 70. FREQUENCY DISTRIBUTION OF SAMPLE SIZES FOR VAISSALA 1-MINUTE AVERAGES Affected BY SENSOR FAILURES
